Bradford Soil and Water Conservation District's Questions About the Chemours Trail Ridge South Mine in Bradford and Clay Counties Florida

Paul Still **904 368-0291** stillpe@aol.com **5/8/2024**

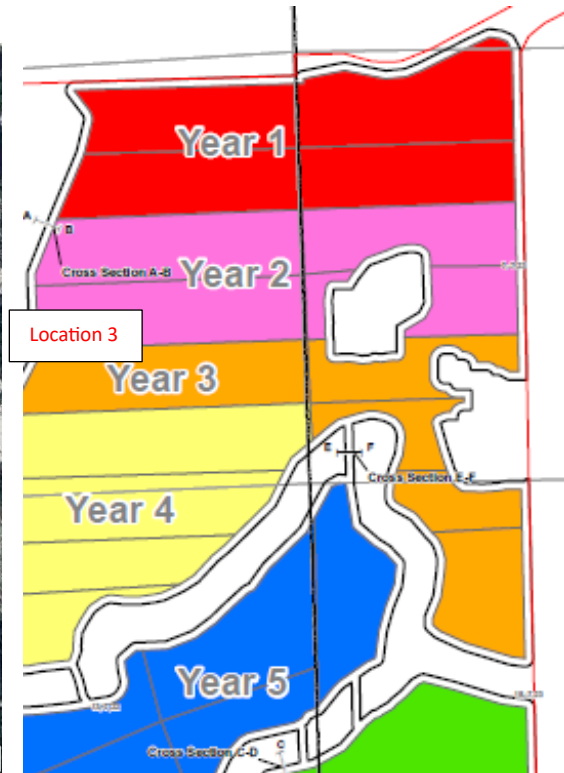
Figure 10 Attachments MMR_137482-018

The disturbed area in the Google Earth image does not appear to match that area noted in the two different Figure 10 images from the two permits.

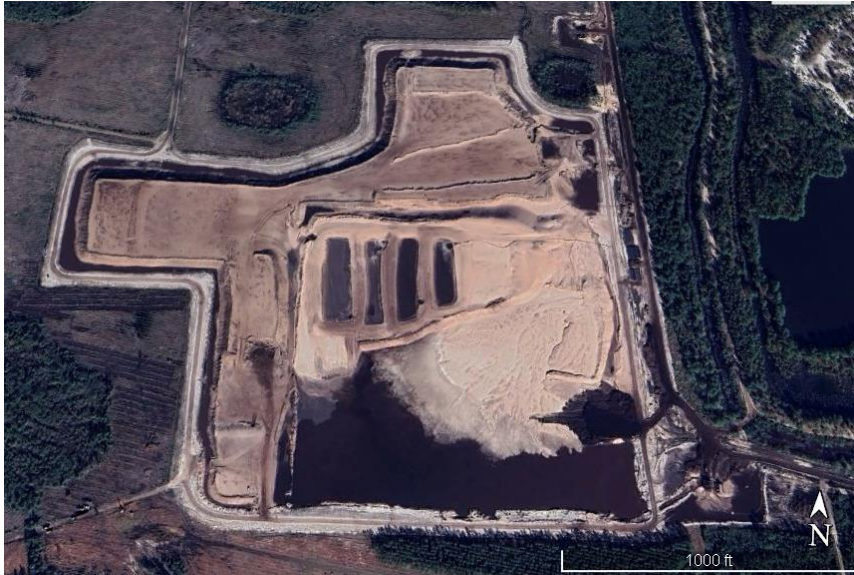
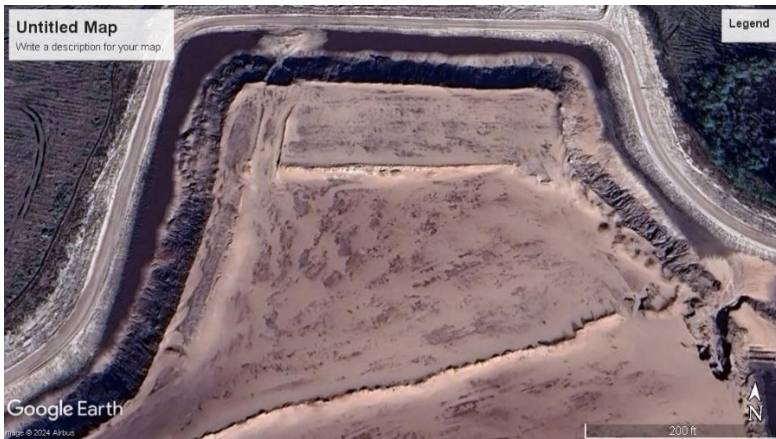
Location 2 Pre-dig Year 1

What are the source of the soils in this image?

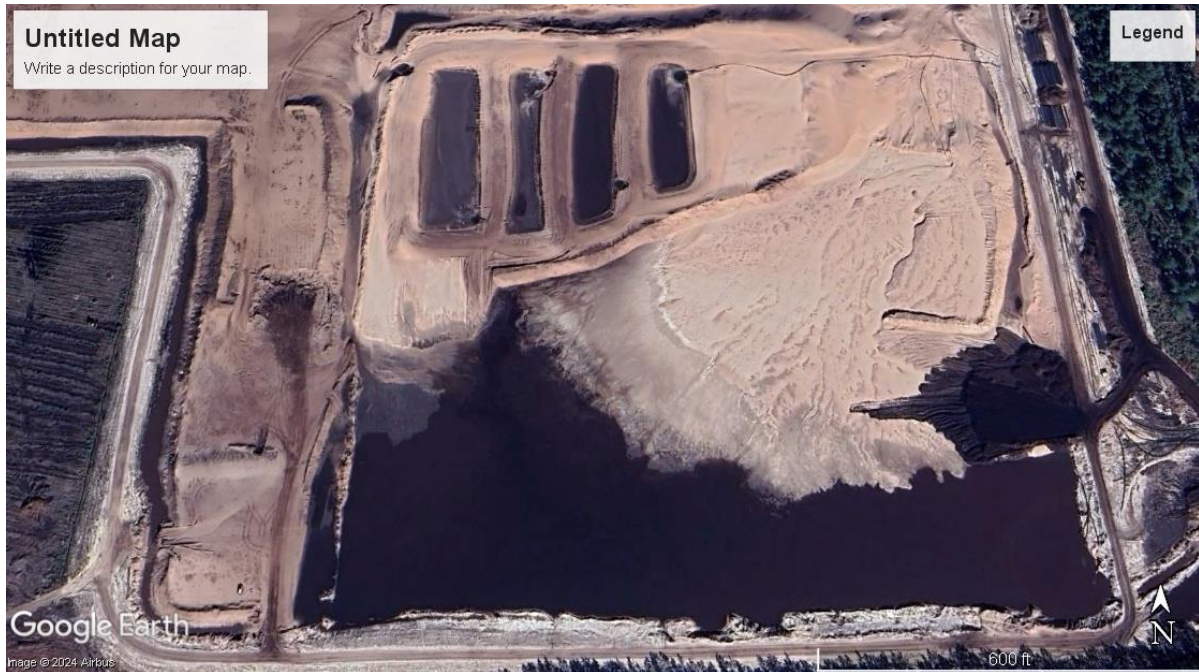
What is the sources of the soils in this image?

What is the source of the water in the image?

What is the depth of the water in the image?

Has the water depth varied over time?

What is the height of the permitter berm?

What are the materials piled to the east of the permitter berm in the upper right corner of the above image?

What prevents water flow from moving soils to the east of the piles of materials?

What is the function of the 4 ponds at the top of the image?

What is the black material being deposited in the southeast part of the site?

What are the soils in the tall pile on next to the water on the west side of the site?

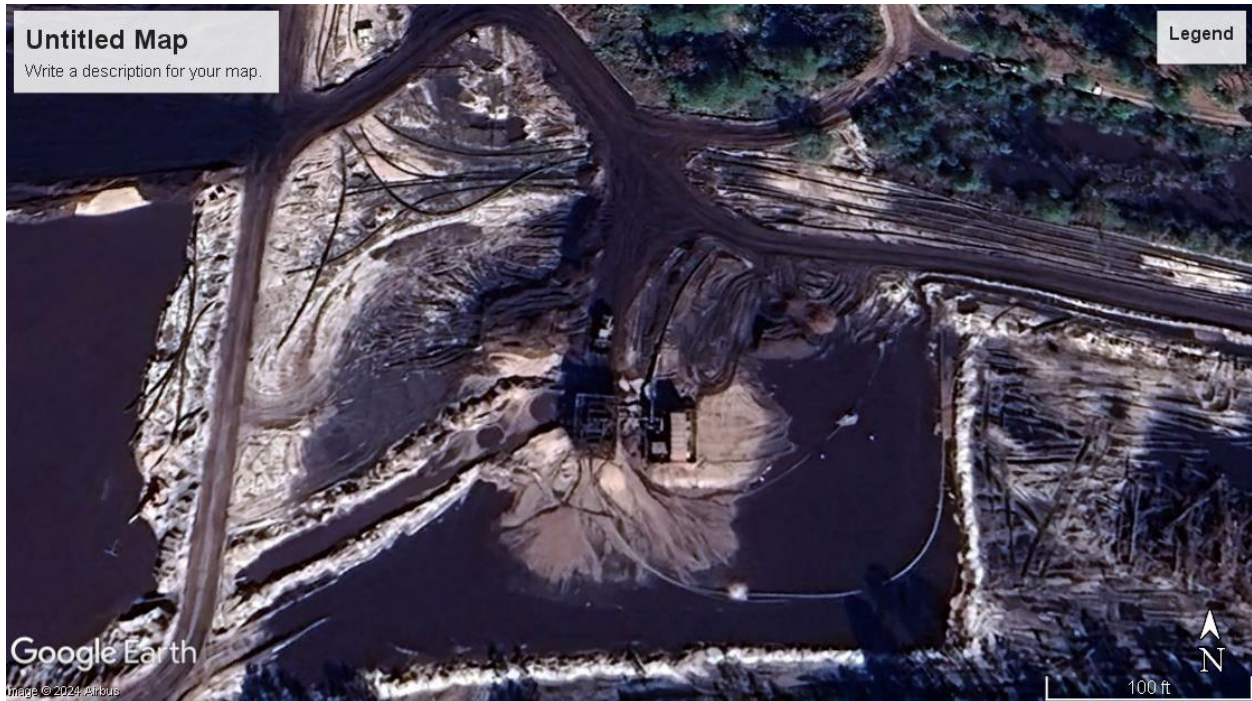
What is the function of the unit in the above image of the southeast corner of Location 2?

When was this unit installed?

Why is this disturbed area around the unit not noted in the 2023 Annual Report?

Do the perimeter berms for the unit meet the permit requirements?

Many black pipes can be seen in this image and throughout the mine site. What is the plan for removing the pipes as the pipes are replaced, are no longer used or after mining has been completed?

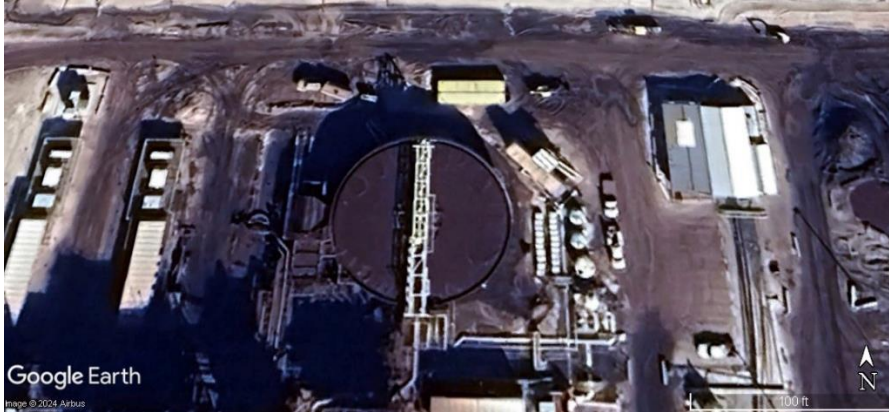
Is the thickener referenced in g the round unit in the above image?

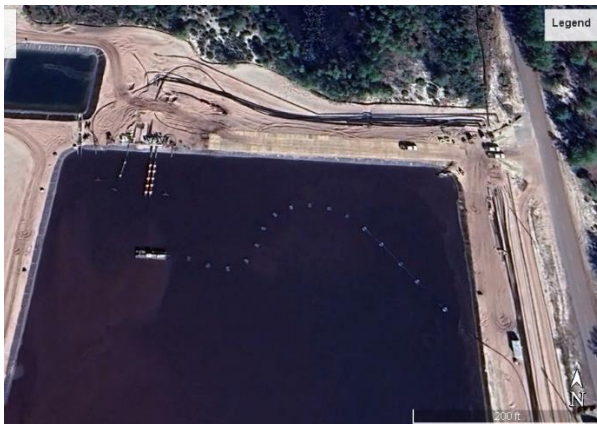
Is the dredge seen in the process pond in the above Google Earth image on the right the dredge referenced in g?

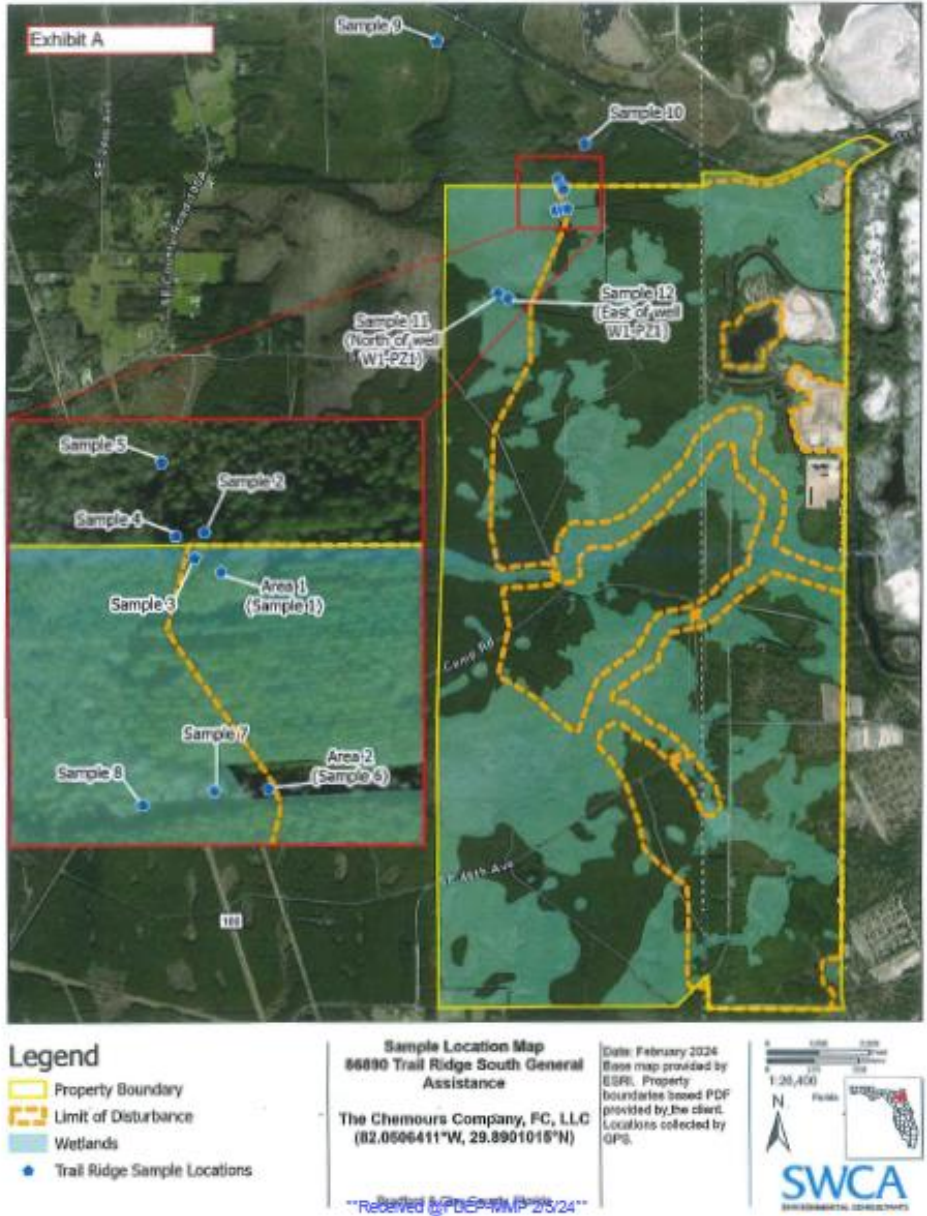
Are Samples 2 and Sample 4 on NFLT property?

Why is the location of the berm breach not shown on the image?

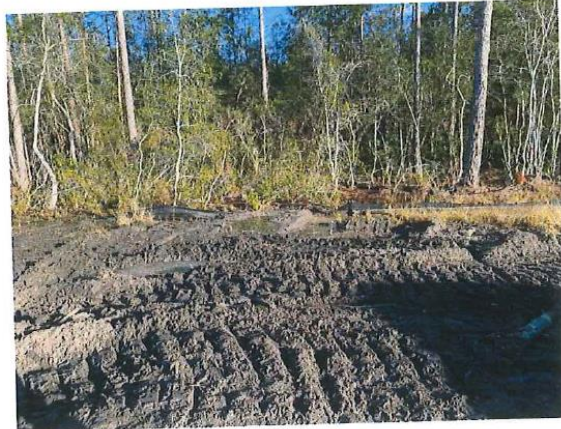
Northwest Corner Reclamation cell – Where water entered wetland
(January 31, 2024)

Is the above image from Area 1?
Page 7

What is the exact location of this image?

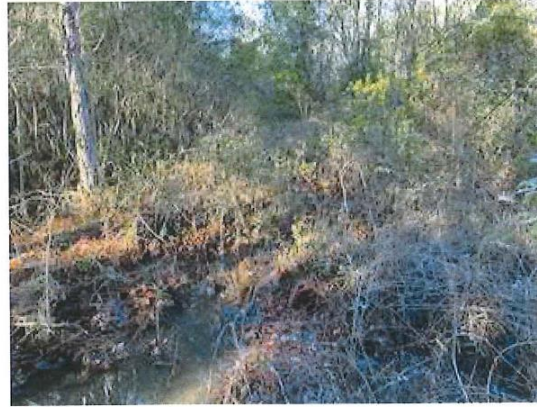
Firebreak
(January 31, 2024)

What is the exact location of this image

What is the grey material seen under the water in the above image?

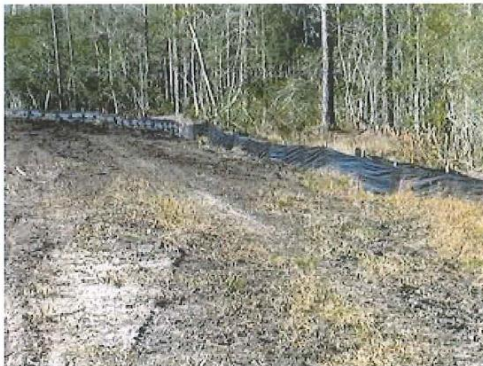
Silt Fence Repaired (January 31, 2024)

What is the exact location of the above image?

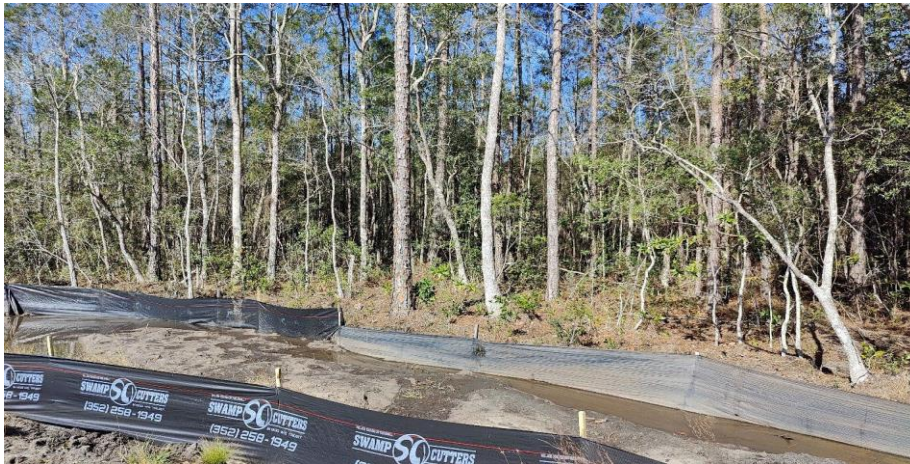
Area 1, showing double row of silt fence containing standing water.

Is the light grey material on the old silt fence in the above image sediment deposition?

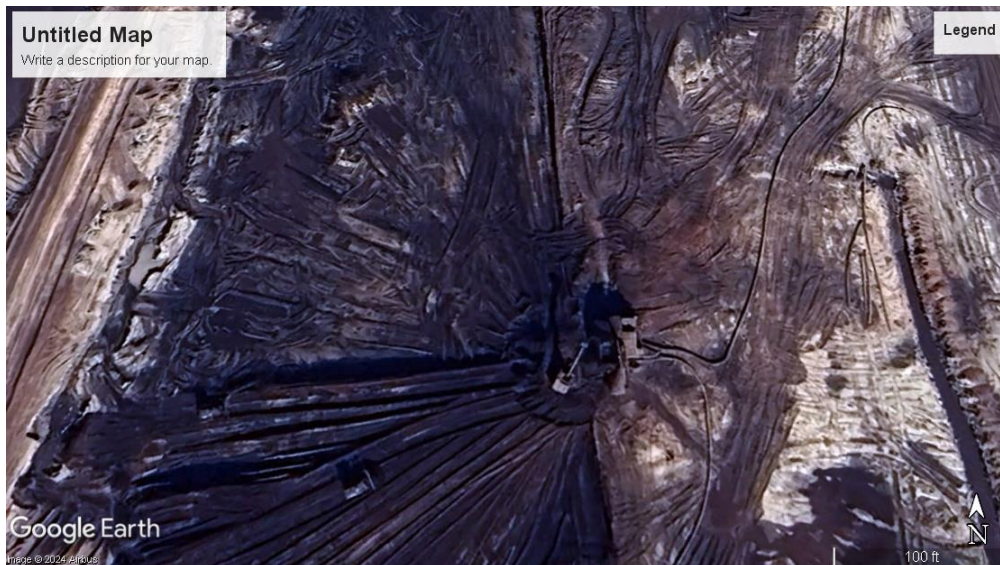
The Location 1 active mine cell MMU above appears to be receiving muck top soils. Where are the muck soils being deposited?

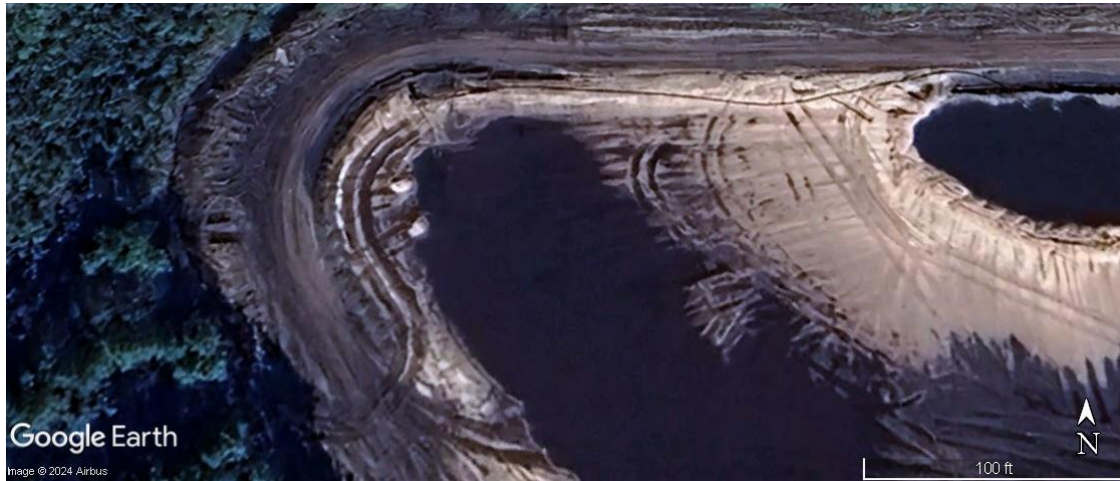
The pump in the Google Earth image above appears to be the same pump as in the image from 1/31/2024 on page 23 of this document. Based on the position of the black pipe just inside of the berm, it appears that there was significantly more water on 1/31/2024 than was present on 1/29/2024.

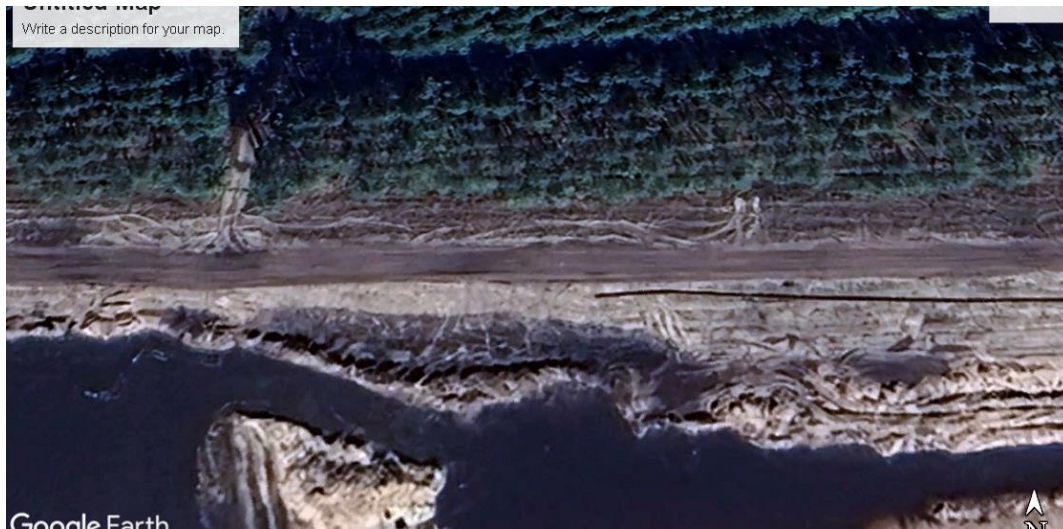
Does the berm at the water edge in the 1/31/2024 image meet the design requirements of the permitter berm?

Why was the north south berm cut through on its northern end?

Was there any indication on 1/29/2024 that water was seeping through the thin berm section where the black pipe becomes visible?

Was there seepage in this area on 1/31/2024?

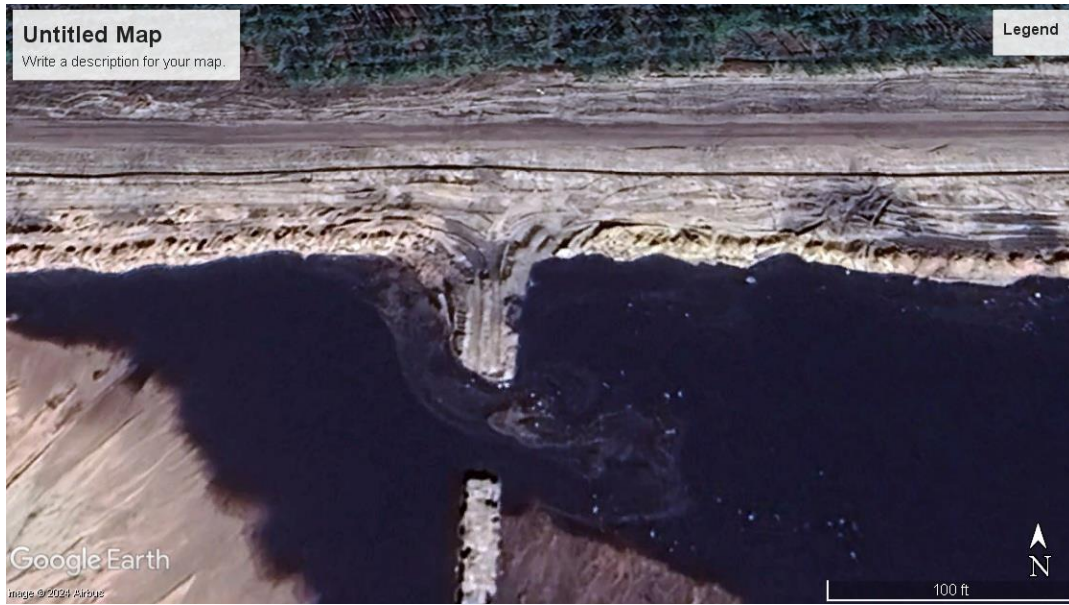
Why was this breach in the north south berm allowed to remain?

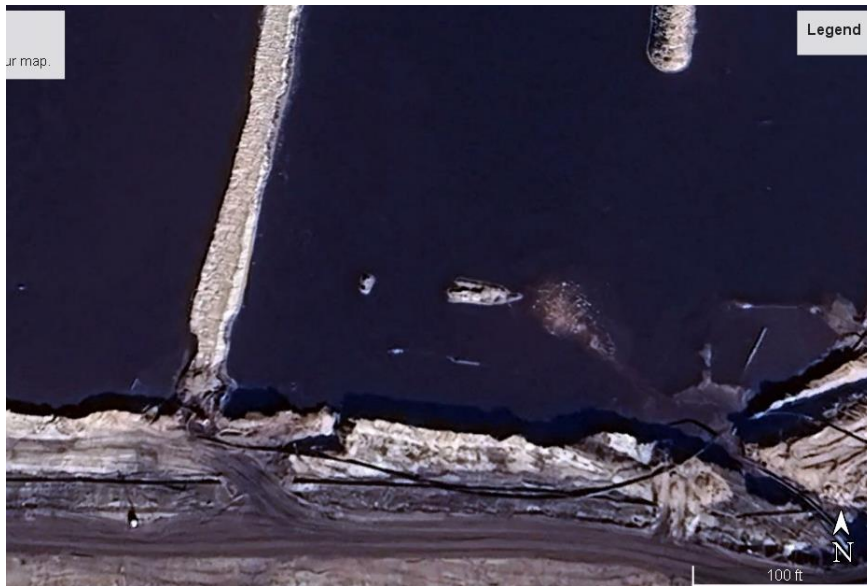
Is the berm failure in the above image of the north south berm the failure noted in the 5 day report that stated a *“washout” by the active tailings line which caused water to flow back toward the reclamation cell.*”

What is/was the purpose of the pump at the end of the north south berm?

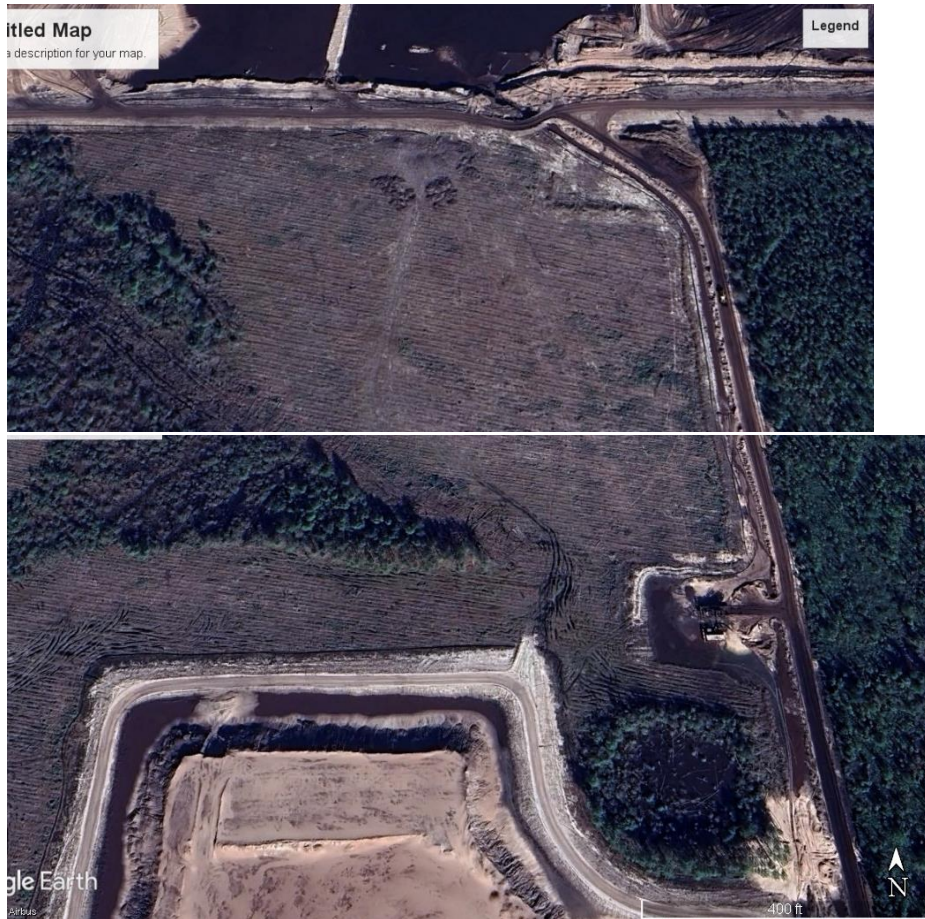
Location 1 South Ditch and South Unit

The Location 1 cells appear to be connected by a roadside ditch to the unit and wetland in the bottom image above.

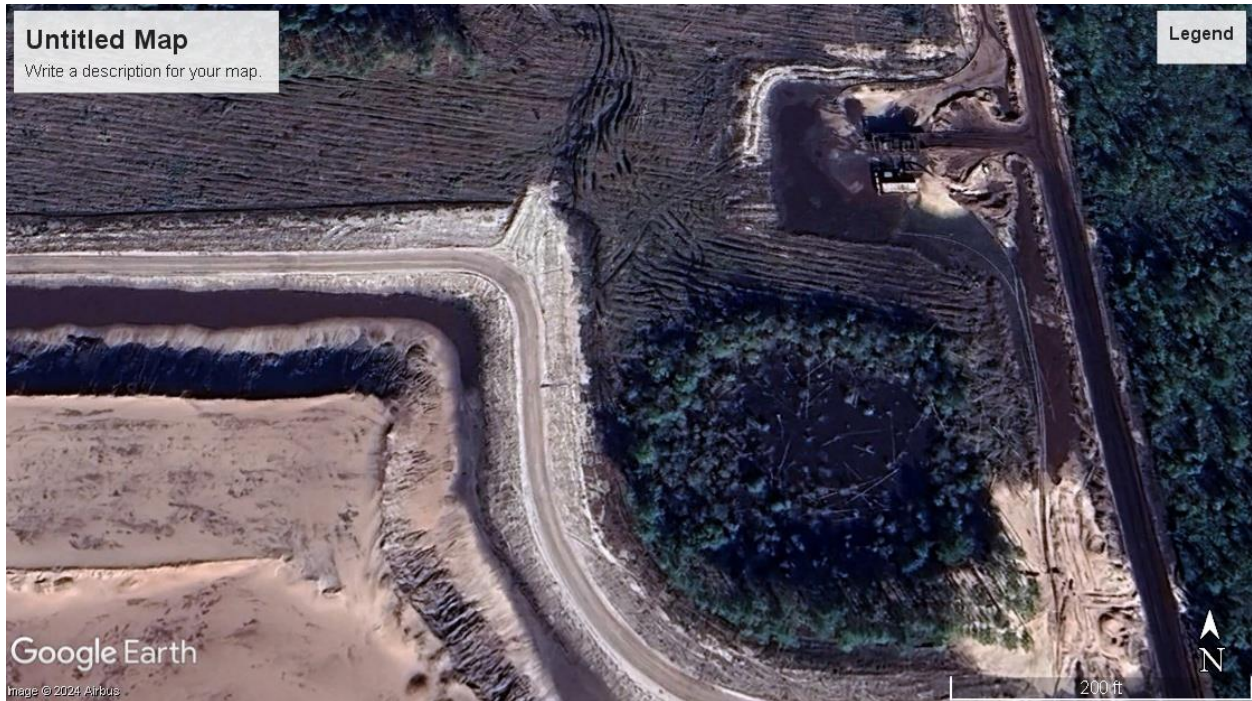
What is the function of this unit?

When was the unit installed?

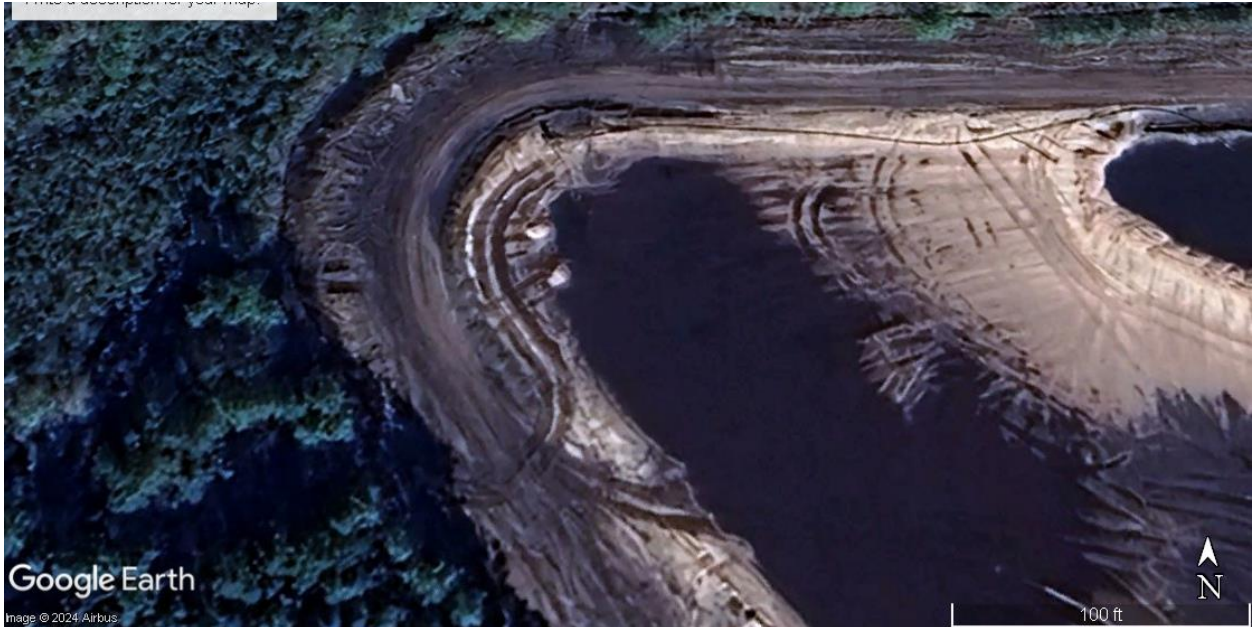
Google Earth 1/29/2024

The above image shows the pump and water level in relation to black pipe on 1/29/2024 and the two points of discharge on 1/31/2024 Area 1 to the north and Area 2 to the west.

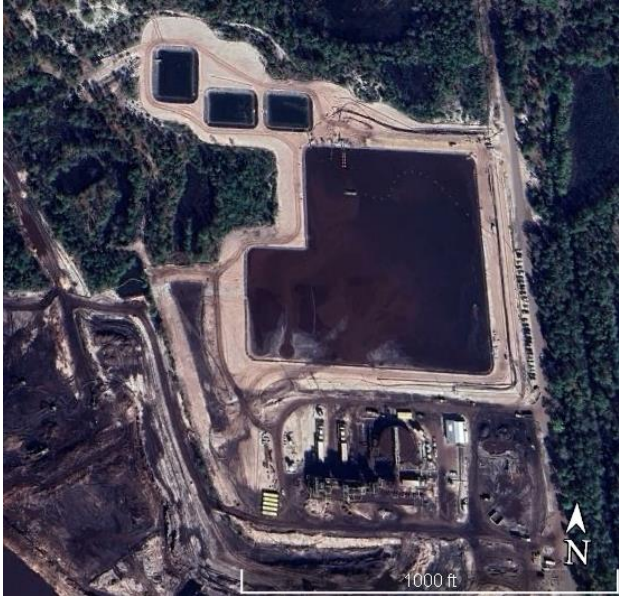
What is the black substance covering the area and roads in the above image?

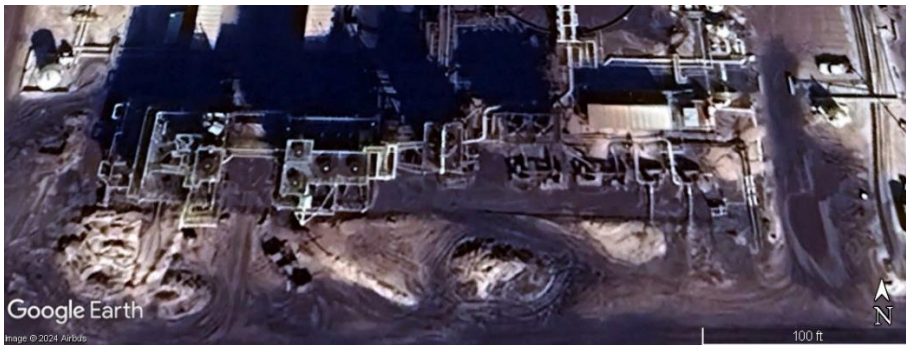
What is the function of the above unit?

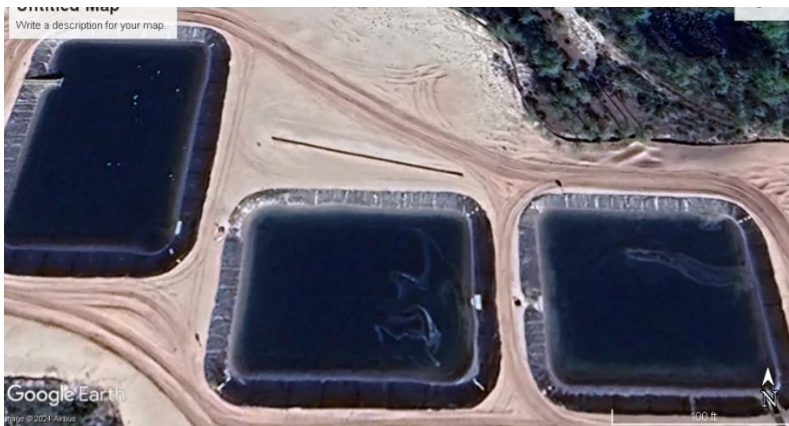
How are the IWW ponds being kept below the discharge level?

What is the radium levels of the water remaining in the 3 ponds?

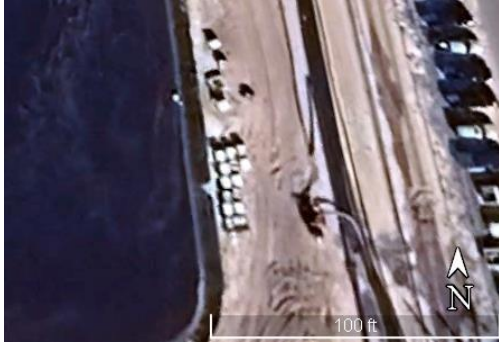
What are the structures in the southeast corner of the process pond?

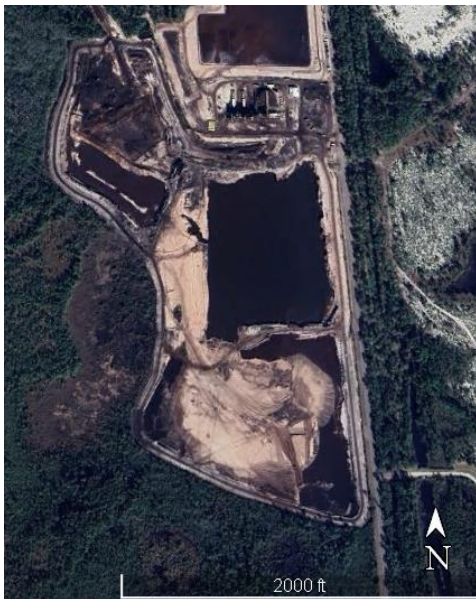
Questions for Location 4 Southeast Mine Cell

Why have the tailing and reclamation at this location not been completed?

What were the radium levels of the discharge water when this area was mined?
