Bradford Soil and Water Conservation District's Questions About the Chemours Trail Ridge South Mine in Bradford and Clay Counties Florida

Paul Still **904 368-0291** stillpe@aol.com **5/8/2024**

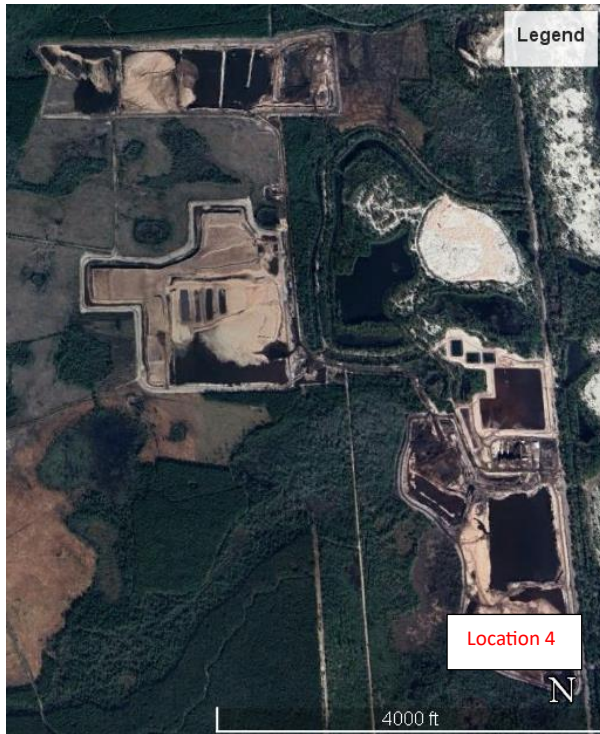
Google Earth 1/29/2024

The disturbed area in the Google Earth image does not appear to match that area noted in the two different Figure 10 images from the two permits.

Do the activities seen in the Google Earth image meet permit requirements with respect to timing of mining activities?

Should the two Figure 10 maps be updated with a permit modification?

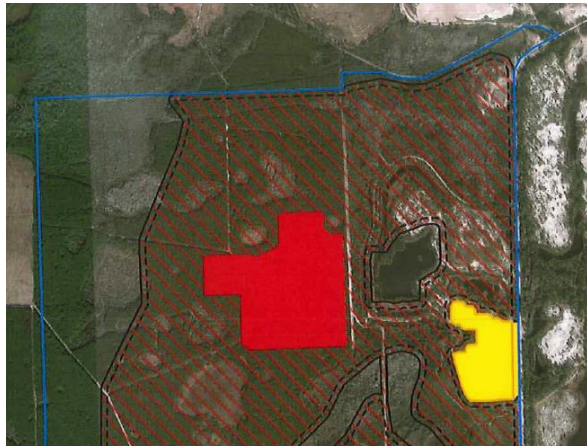
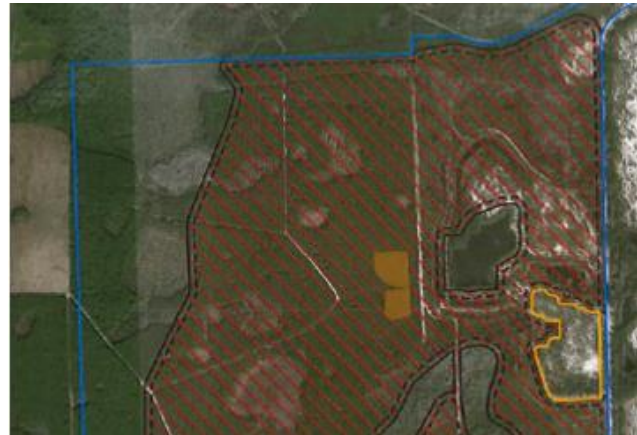
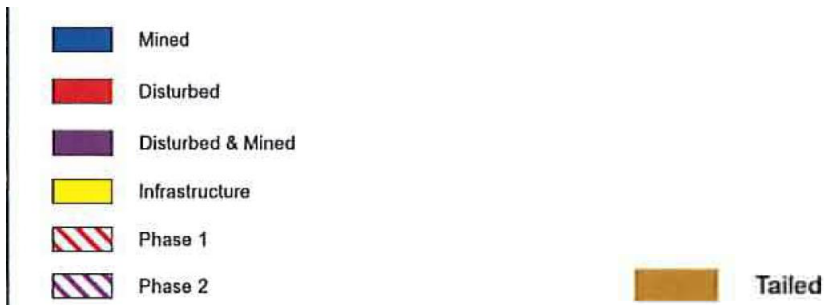
From 2022 Annual Report Figure 1
Mined/Disturbed

Since the heavy mineral sands have been removed and stockpiled, should the pre-dig pit area in tan in the image on the right be shown as disturbed & mined in the image on the left?

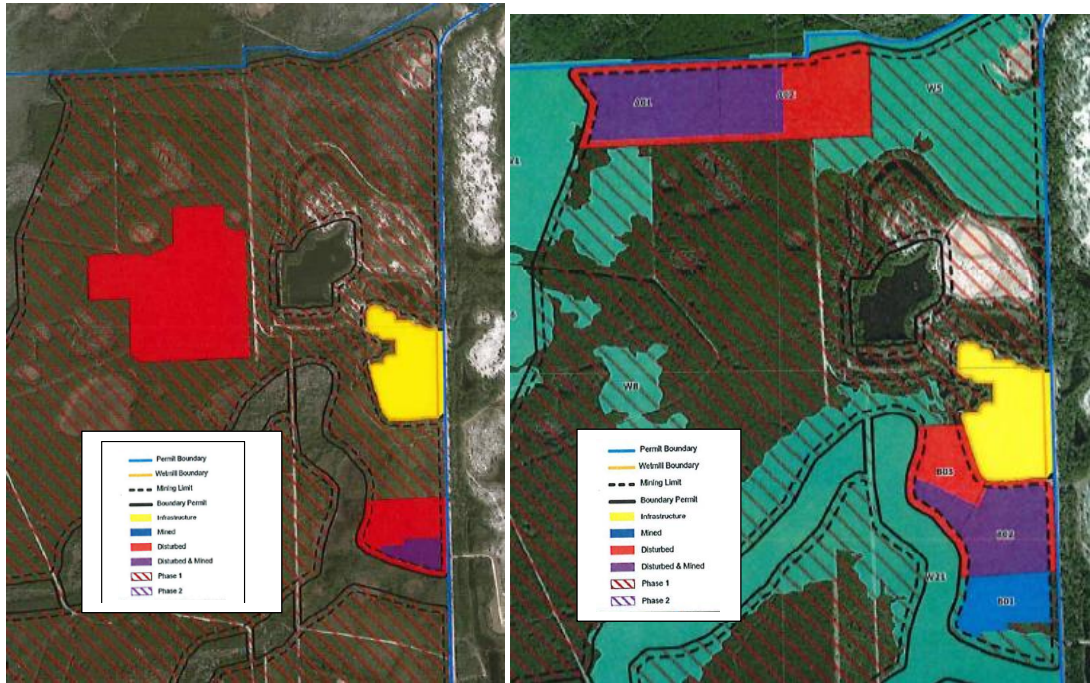
From 2022 Annual Report Figure 3 2023 Annual Report Figure 1 Mined/Disturbed Reclamation Status 2022

Is Figure 1 from the 2023 Annual Report misleading because it does not show the disturbance noted in the 2022 Annual Report and the current conditions seen in the 1/29/2024 Google Earth Imagery?

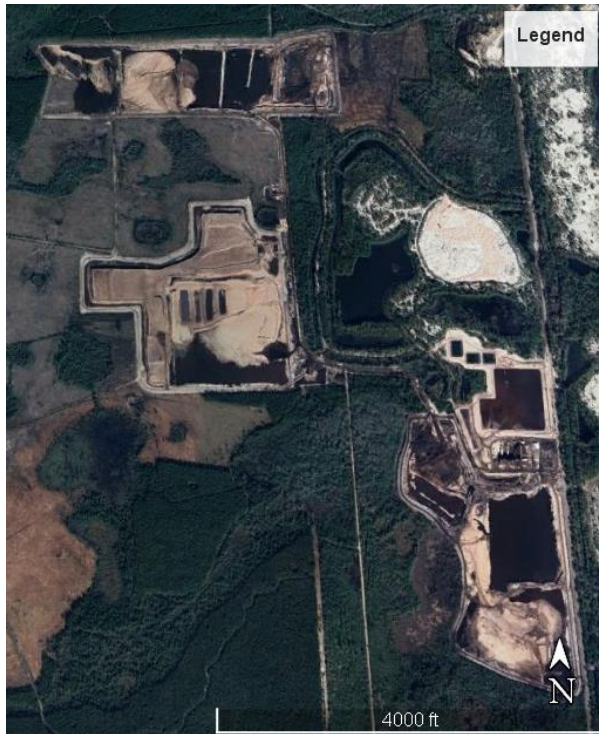
Google Earth 1/29/2024

Does the 2023 Annual Report accurately describe the disturbance, mining tailing, and contouring in the Google Earth image?

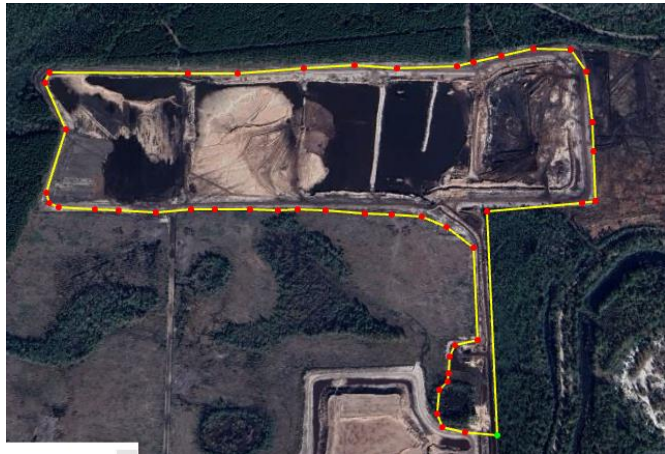
Location 1 Northwest Mine Cell

81.81 acres

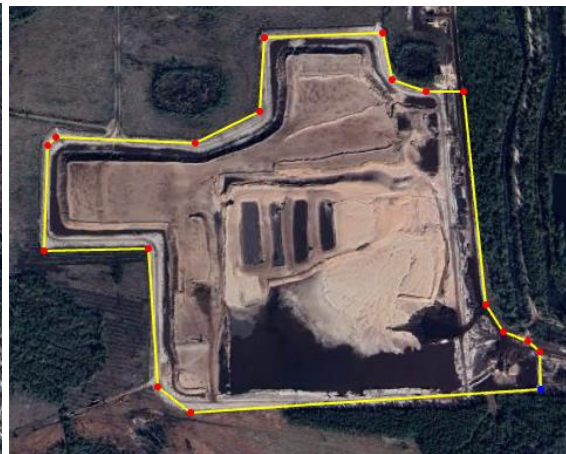
Location 2 Pre-dig Year 1

87.28 acres

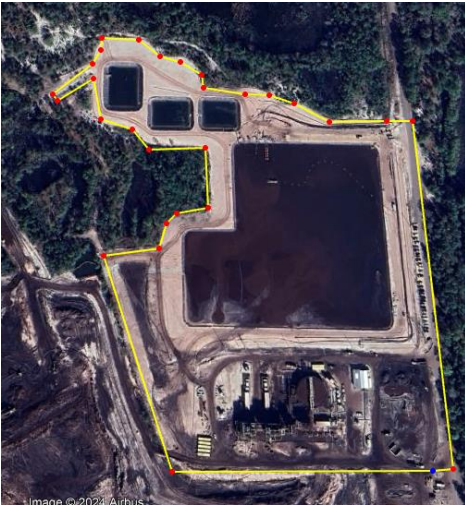
Location 3 IWW Treatment Ponds, Process Pond, and Plant Units

30.45 acres

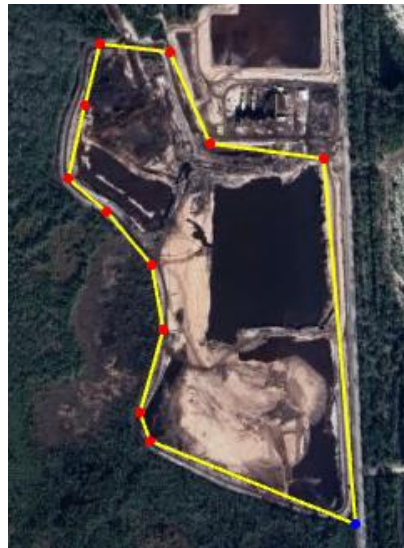
Location 4 Southeast Mine Cell

68.02 acres

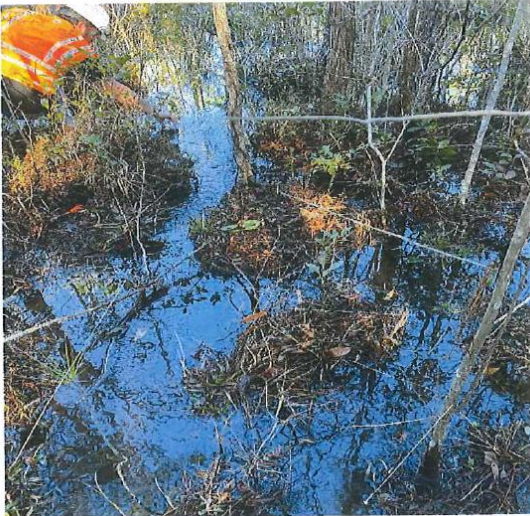
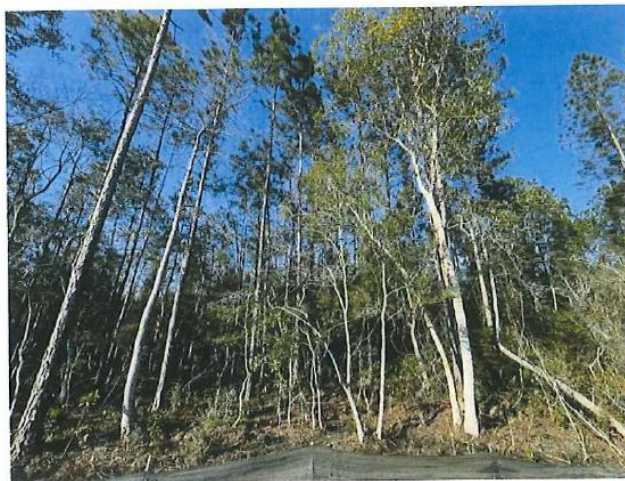
Representation of Wetland
Sample 5 (January 31, 2024)

Northwest corner Reclamation Cell
Representation of wetland (February 1, 2024)

What are the exact locations of two above images?

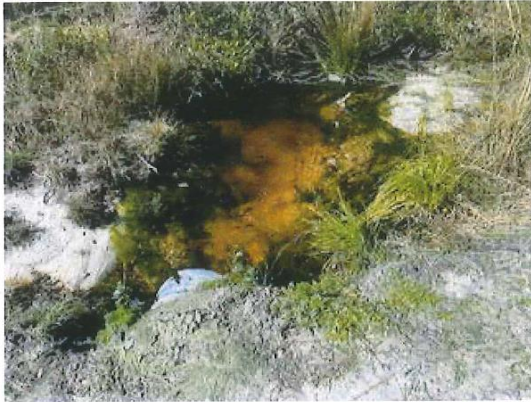
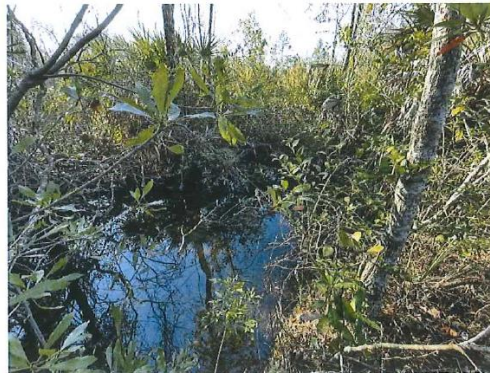
Perimeter Sample Location 9 (January 31, 2024)

Perimeter Sample Location 10 (January 31, 2024)

What are the exact locations of two above images?

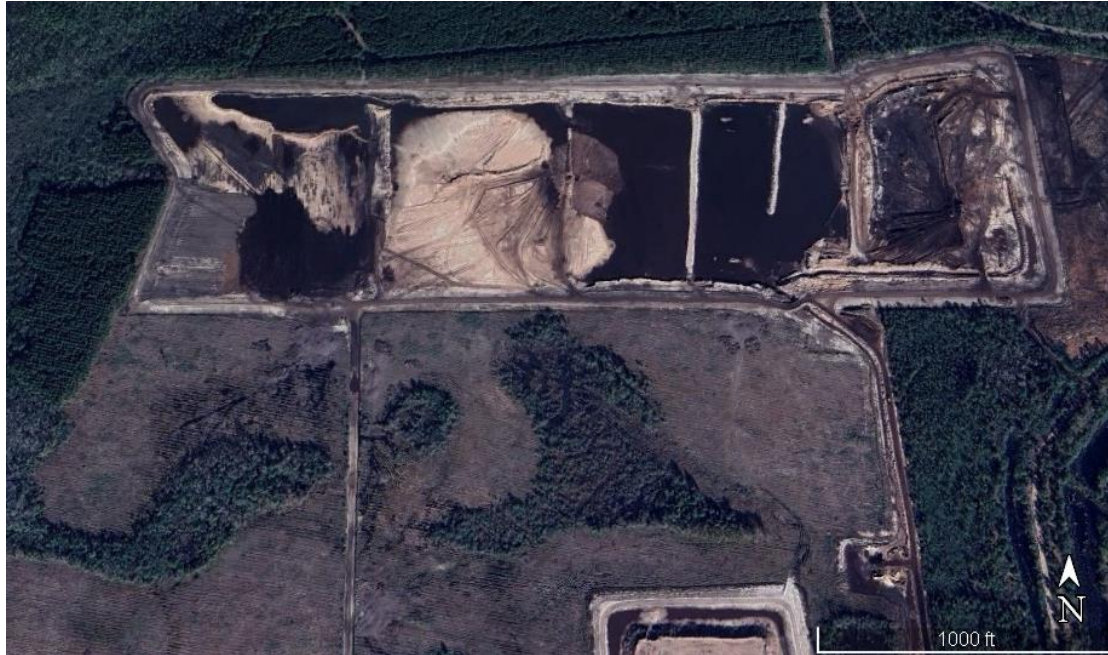
Location 1 appears to have 4 completed mine sections, 1 active mine section and a processing unit to the south just to the east of the north perimeter of Location 2.
